# Aviation Investigation Preliminary Report

| <b>Location:</b> | Halloran Springs, CA | <b>Accident Number:</b> | CEN24MA111 |
| <b>Date &amp; Time:</b> | February 9, 2024, 22:08 Local | <b>Registration:</b> | N130CZ |
| <b>Aircraft:</b> | Airbus Helicopters EC130 | <b>Injuries:</b> | 6 Fatal |

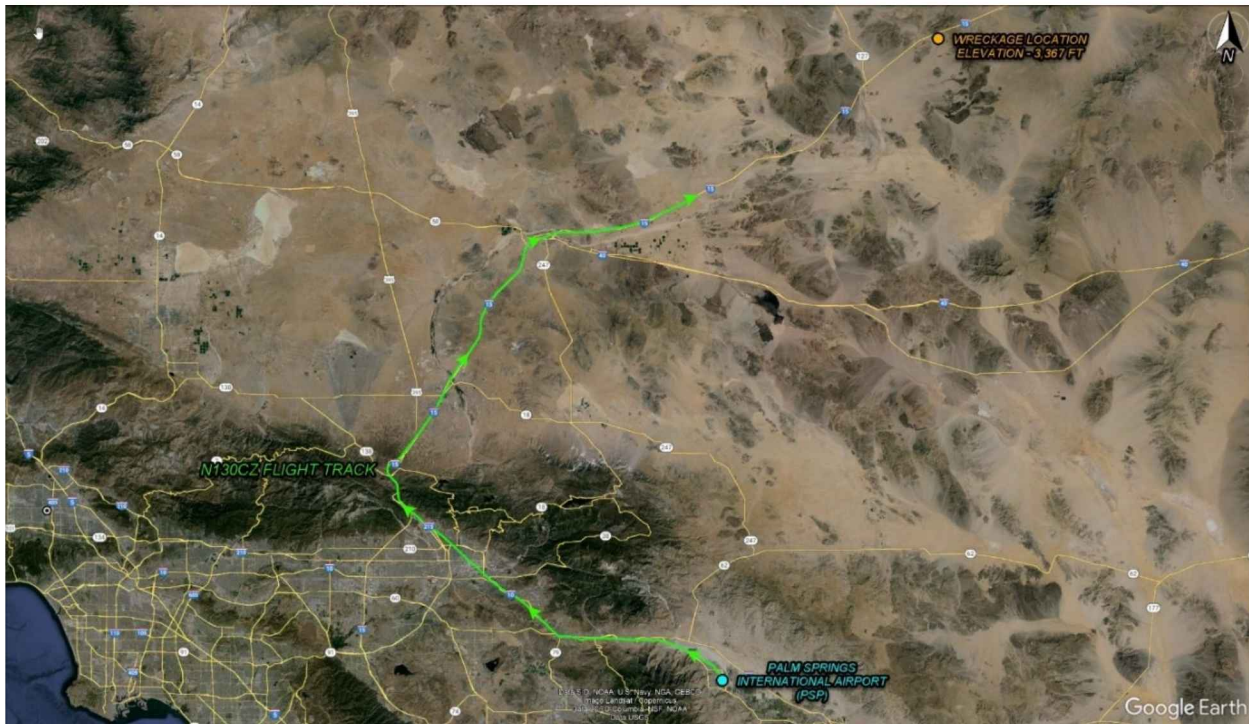
Figure 1. Overhead view of accident flight track.

The helicopter followed I-15 toward the planned destination of Boulder City Municipal Airport (BVU), Boulder City, Nevada, climbed between 4,000 - 5,500 ft msl, then descended to about 3,500 ft msl near Barstow, California, where the ADS-B track data was lost about 2146, likely due to terrain interference. ADS-B data resumed at 2207 near the Halloran Springs/I-15 exit west of the accident location. The last ADS-B data points for the flight tracked east-southeast, gradually descended in altitude, and increased in ground speed (see Figures 1 and 2). The accident site was located 0.31 miles east-southeast of the last data point at an elevation of about 3,360 ft msl.

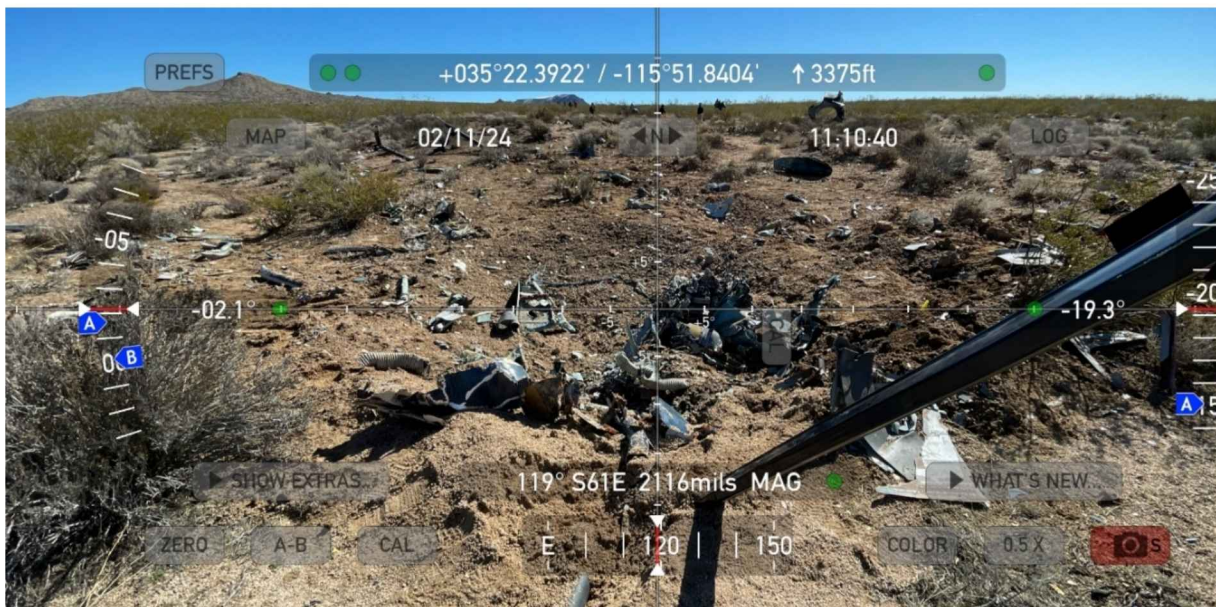
The wreckage was located in high mountainous desert and scrub brush covered terrain, and debris were scattered about 300 ft along a 120° magnetic heading from the initial impact point. The initial impact point, which was a 1.5 ft deep, 12 ft long and 10 ft wide ground crater, contained portions of the right landing gear skid, right skid step, cockpit wiring, and cabin floor structure. The right skid step protruded upward at a 45° angle at the most eastern edge of the ground crater (see Figure 3). Immediately to the right of the crater was a ground divot consistent in the size and shape of the rotor head, with 2 main rotor blade impact marks extending from the divot.

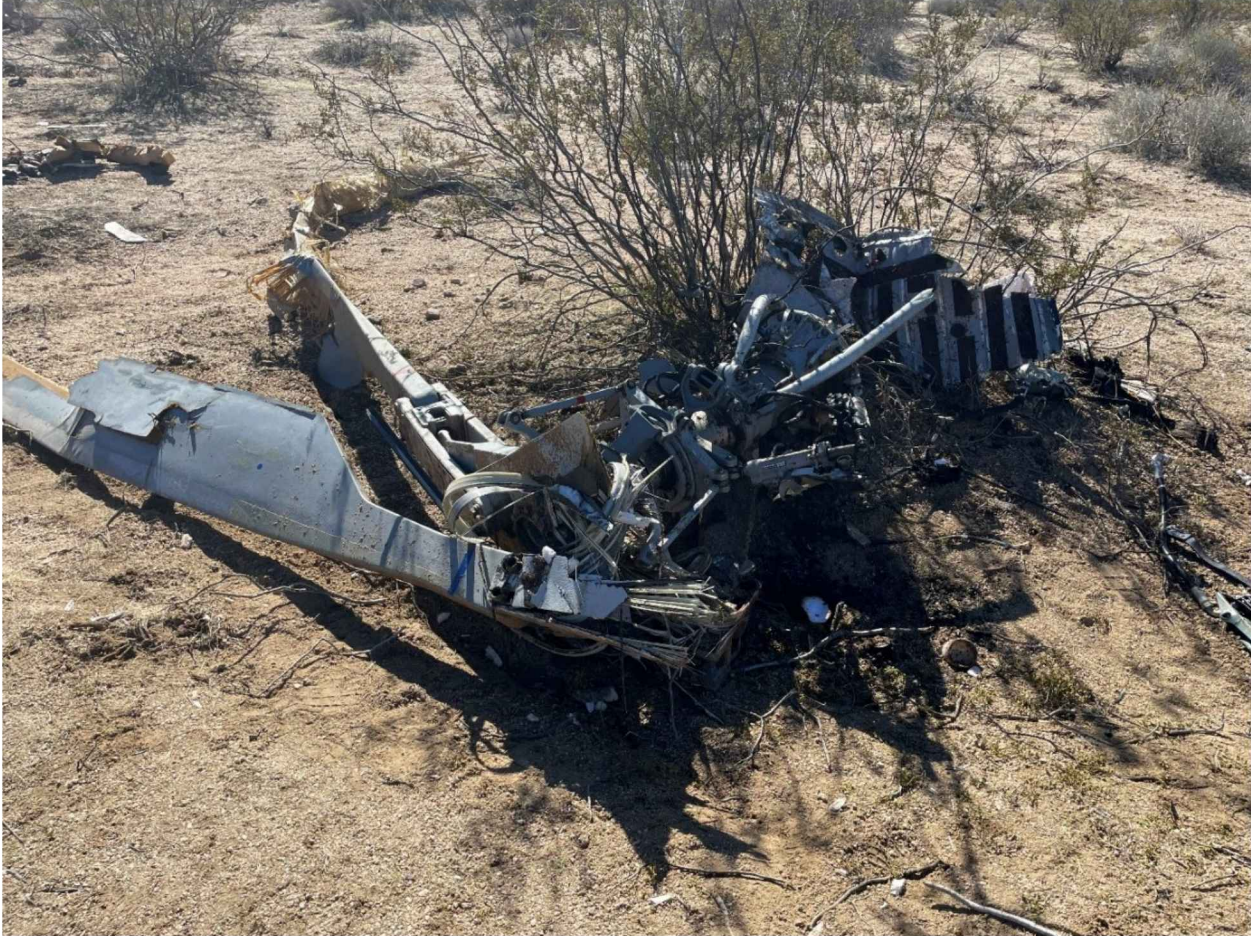
Figure 4. Rotor mast and rotor head.

All major helicopter components were identified at the accident site. The fuselage was fragmented, and the cockpit and cabin were destroyed. Some debris and vegetation displayed thermal damage. The flight control tubes and linkages leading up to the flight control servos were fragmented and continuity could not be verified. All three pitch control links were attached at the swashplate and blade pitch change horns. The main rotor blades were fragmented and broomstrawed, and the blade sleeves and tips were present (see Figure 4).

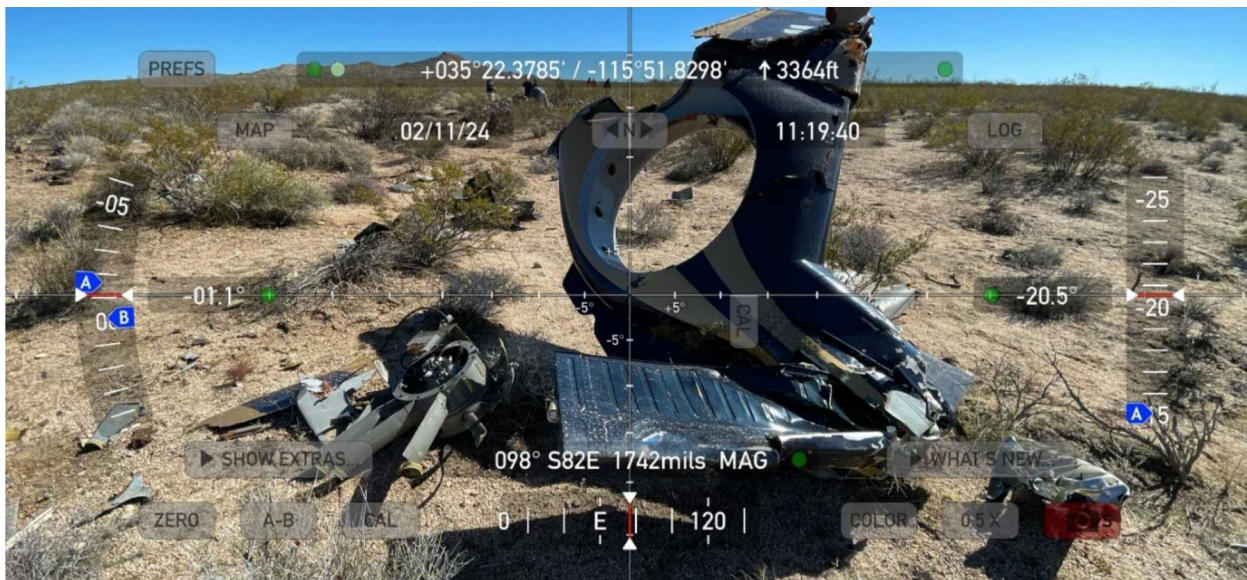
Figure 5. Tail fin and fenestron.

The fenestron tail section with the tail fin and horizontal stabilizer separated from the forward part of the tail boom. All the fenestron blades remained in their hubs and the blade tips displayed chordwise scratches (see Figure 5). The engine displayed rotational damage signatures and metal deposits consistent with powered operations at impact.
